UNITED STATES DEPARTMENT OF AGRICULTURE

MISCELLANEOUS PUBLICATION No. 165

THE BARRIER SYSTEM FOR CONTROL OF FLOODS IN MOUNTAIN STREAMS¹

By L. M. WINSOR, *irrigation engineer, Division of Irrigation, Bureau of
Agricultural Engineering*

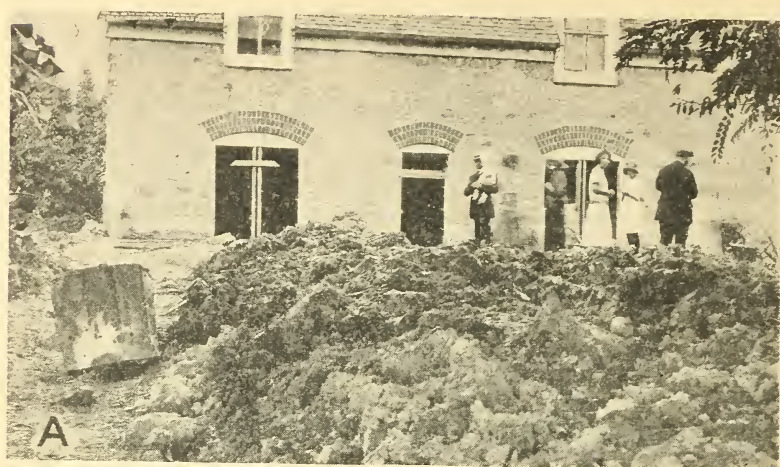
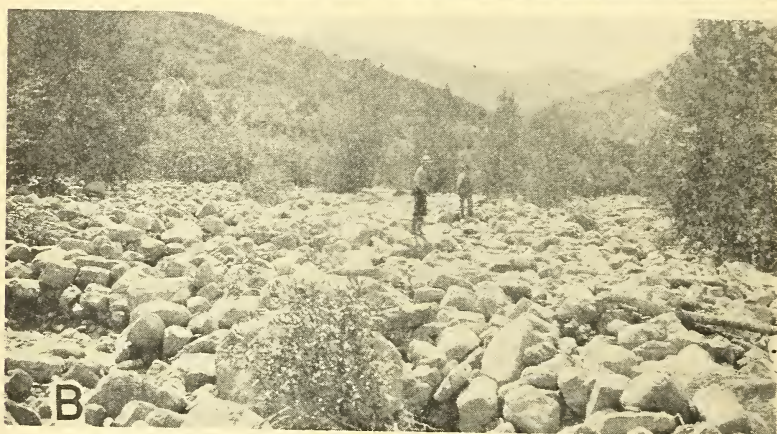
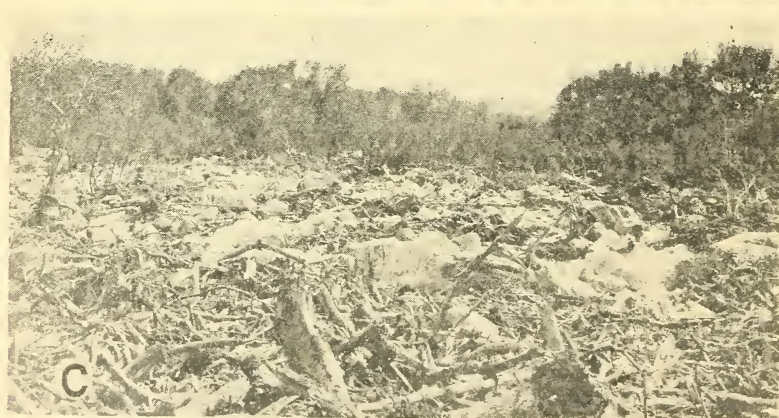
FIGURE 3.—*A*, Main Street, Willard, Utah, after flood of August 13, 1923; *B*, deposit of boulders left by Canal Creek flood, July 1922; *C*, debris deposited above Farmington, Utah, barrier by the flood of July 3, 1926.

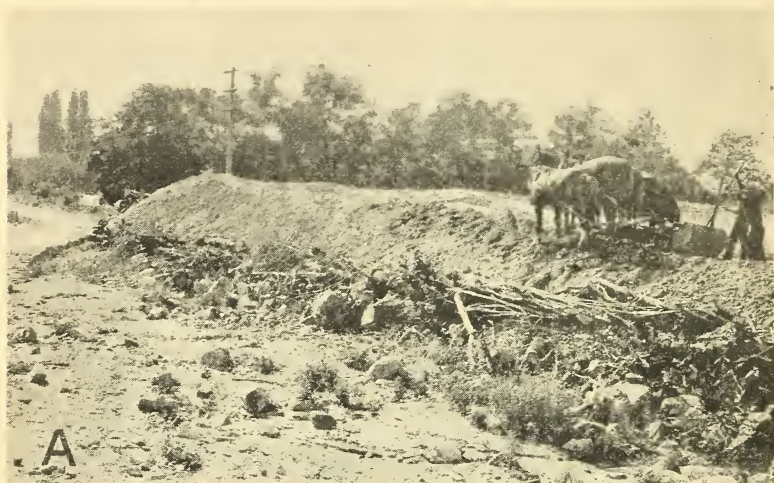
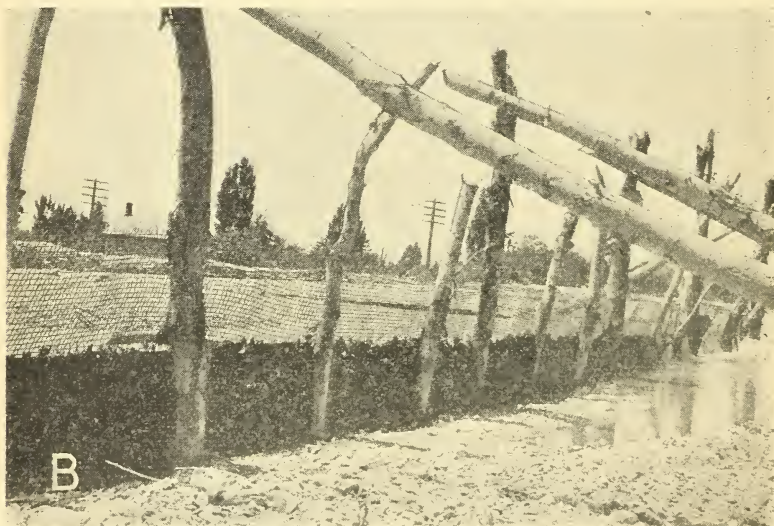
FIGURE 6.—*A*, Scraping gravel to outer edge of dike at the close of a season; *B*, fence of woven wire used for a drift dam.

The barrier and dikes are built out of whatever material is available at the site, and may be sand, gravel, or boulders or earth banks protected with gravel or crib facing (fig. 6, A). It is not necessary that these structures or their foundations be impervious, since their purpose is to arrest the movement of the water and to guide its direction of flow. Dikes which were pervious when constructed often become impervious through the silting up of interstices.

The purpose of drift dams is to direct the flow of spring floods from place to place within the basin. These structures are temporary and are moved or else covered up as the gravel flow is light or heavy. These dams are built of trees and brush, of posts to which wire screen is tacked, or of posts interwoven with willows and brush. The materials most used are cottonwood or cedar trees held in place with posts or boulders. Any materials may be used that will direct the stream flow. The number of drift dams and their location is entirely a matter of judgment, but usually 2 to 5 will be in use at the same time. Figure 6, *B* shows a fence of woven wire used for a drift dam.

The inner margin of the floodway was first defined by a fence of closely woven wire with posts heavily braced (fig. 6, *B*). Gravel deposited against this fence and between it and the dike was scraped onto the dike to keep it above flood height. When the fence had been covered with gravel, a cribwork of stumps from damaged orchards was built above it, and straw, rocks, and tree tops were used in stopping heavy leakage through the crib. Year by year the dikes about the basin have been raised in this way until what was a ridge after the flood of 1923, has become a depression through the bottom of an area that slopes from all sides toward the spillway. The deflectors at the upper end of the basin were built of logs, timbers, brush, straw, and rocks placed during floods and soon covered by sand and gravel deposited by the water.

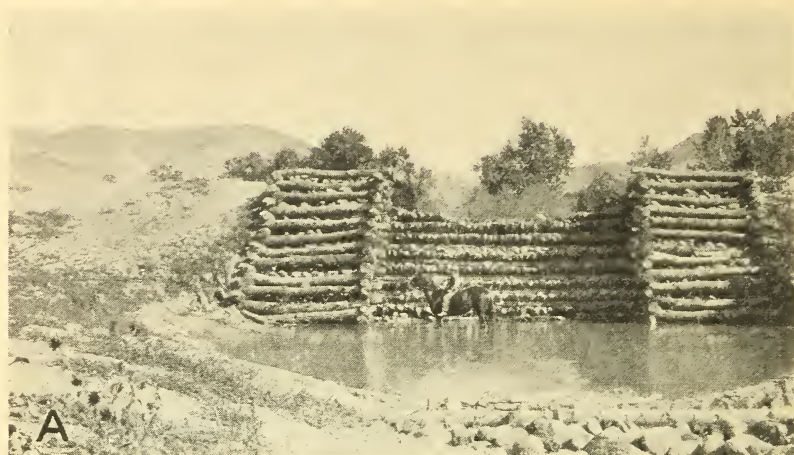
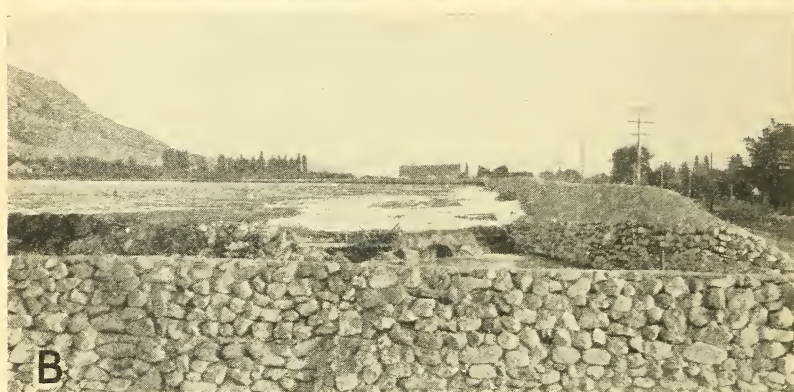
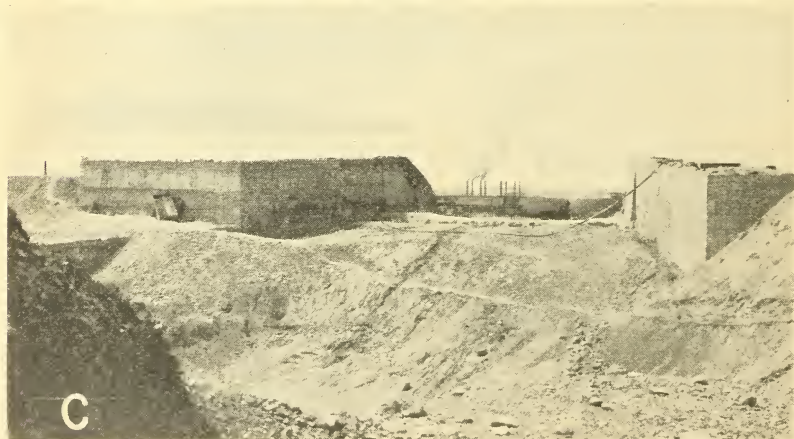
FIGURE 9.—*A*, Timber and rock spillway, Kanosh Creek, Utah; *B*, rubble masonry spillway, Willard, Utah; *C*, spillway with reinforced concrete wings, Kessler Canyon, Utah.

The advantage of timber and rock construction is that it can be built with a minimum of expense. The greater part of the materials used are generally available at the site; skilled labor is not required, and where the labor is furnished by the interested parties, the cash expenditure may not exceed 10 percent of the total cost. The disadvantages of this type of construction are its comparatively short life and its permeability. One type of timber and rock spillway is shown in figure 9, *A*.

The investigations herein reported indicate that the best rubble structure is one that will stand without mortar and in which concrete is used merely to fill the voids and to decrease leakage. When available, pear-shaped boulders, 2 feet or more in length, should be used. For the floor and crest they should be laid with the smaller ends tilted downward and pointing upstream. After one course is laid, concrete should be spaded between the rocks to within 6 or 8 inches of the top surface. The second course is laid so that each rock rests upon two boulders in the lower course. A rubble-concrete spillway is shown in figure 9, *B*.

Especial care must be taken in getting good foundations for concrete structures so that there will be no settlement or cracking. A spillway with reinforced concrete wings is shown in figure 9, *C*.

The check-dam system having failed, the barrier system of control was adopted. The principal construction consists of an embankment 3,200 feet long across the mouth of Kessler Canyon, with a rubble-concrete spillway (fig. 9, *B*). The embankment is 15 feet high, and has a base width of 150 feet and a crown width of 40 feet. The upper crest of the spillway is 64 feet, and the tops of the wing walls are 79 feet above the stream bed. Such height was required because of the depth of the gorge that had been cut through the deltaic formation of old Lake Bonneville above the smelter plant. The spillway rests upon alluvium, and although this might be considered hazardous for so high a structure, thorough examination 3 years after the system was completed disclosed no indication of settlement or of cracks.

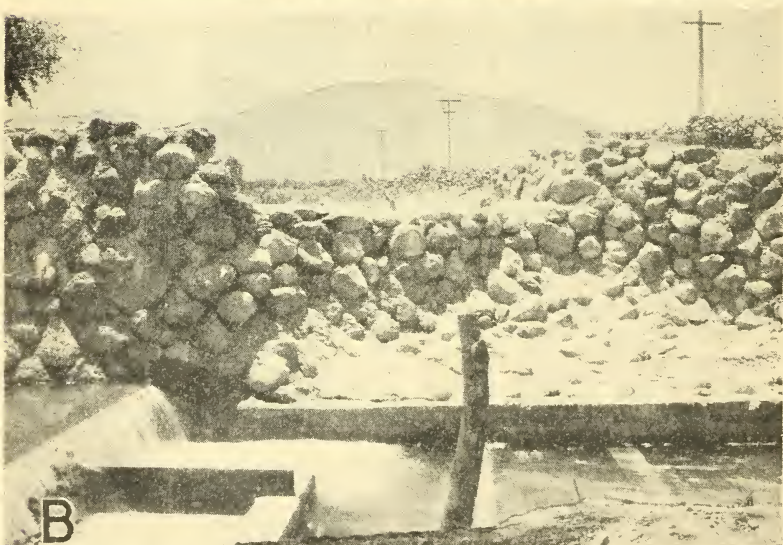
FIGURE 11.—A, Farmington barrier spillway just before being raised in 1931; B, looking upstream through Santaquin barrier spillway—barrier basin lies at one side of low-water channel. Immediately to right of weir crest, placement of boulders in two vertical lines is faulty; elsewhere it is fairly good.

The wire checks failed to hold back the gravel, and canal cleaning became so expensive that in 1926 the original plan for flood control was adopted (fig. 11, *B*). The control structure was completed in 1927, at a cost of \$500 for embankments and \$660 additional for the spillway. Previously the cost of ditch cleaning had averaged more than \$2,000 annually, and much of the water was lost. With the control works, cleaning was reduced to the removal of weed growths and sediment, and all the water was made available for irrigation.
